**Item 10 A-Double Modern Road Train Assessment**

The purpose of this report is to allow Council to make a determination for restricted vehicle access (A-double Modern Road Train access) on a 12.180km section of County Boundary Road (SR41), south from the intersection of Gil Gil Creek Road (SR63) to the Moree Plains Shire Boundary.

# Gwydir Shire Council Route Assessment Report

## *SR 41 County Boundary Road from Moree Plains and Gwydir Shire Boundary to intersection of Croppa Moree Road (Moree Plains Shire)* Wednesday, 3 July 2013

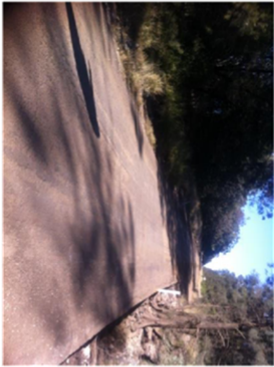
Approximate Measurement Location	Width	Comments	Photos
1.128	Unsealed: 6.1m	Floodway

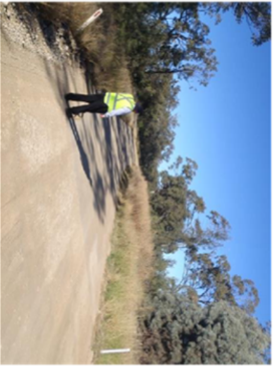
• Causeway (concrete) – 2.887km from the Moree Plains and Gwydir Shire southern boundary – No structural engineer’s report available and therefore structural capacity is unknown.			✓

2.887	Unsealed: 6.2 m Edge to edge: 6.6m Formation: 6.6m	Causeway

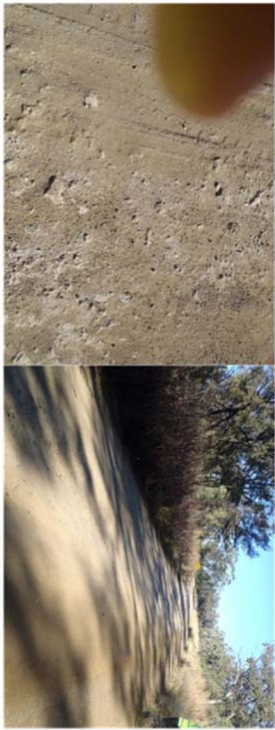
Approximate Measurement Location	Width	Comments	Photos
3.040	Unsealed: 8.0m Culvert: 9.4m Formation: 9.4m	Culvert. Large rocks visible in road surface.

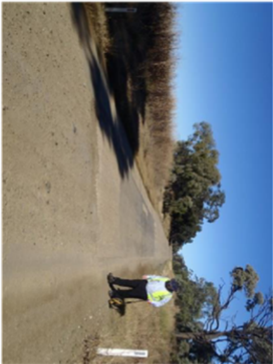
• Causeway (concrete) – 8.856km from the Moree Plains and Gwydir Shire southern boundary – No structural engineer’s report available and therefore structural capacity is unknown.			✓

8,856	Unsealed: 6.2 m Edge to edge: 7.2m Formation: >8.5m	Causeway

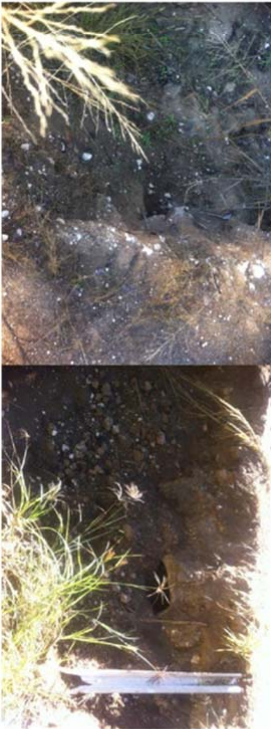
CGSR41_00 1676	1.676	Unsealed: 7.2m Culvert: 7.5m	Concrete, single pipe. Unable to complete a visual inspection of the culvert due to silt build-up blocking the entrance to the culvert. No visible posts or headwalls

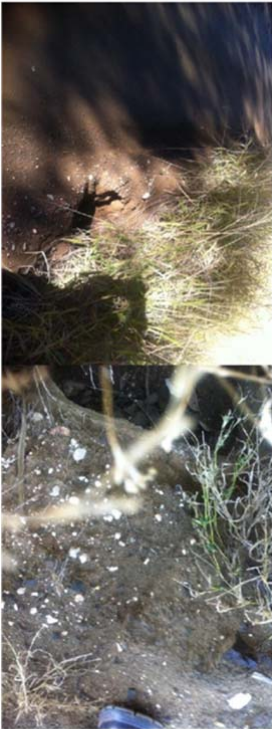
Culvert Id	Approximate Measurement Location (kilometres)	Width (metres)	Comments	Photos
CGSR41_00 2215	2.215	Unsealed: 7.2m Culvert: 7.5m	Concrete, single pipe. Unable to complete a visual inspection of the culvert due to vegetation and silt build-up blocking the entrance to the culvert.

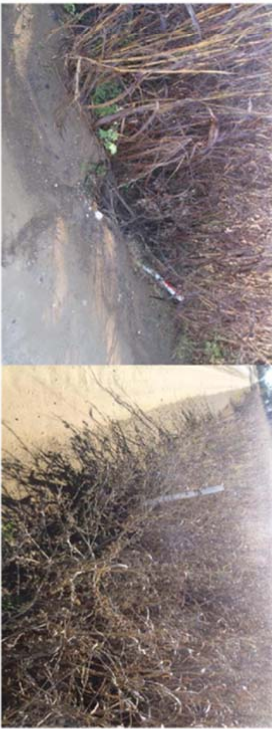
CGSR41_00 3040	3.040	Unsealed: 8m Culvert: 9.4m	Concrete, single pipe. Unable to complete a visual inspection of the culvert due to vegetation build-up blocking the entrance to the culvert. No visible

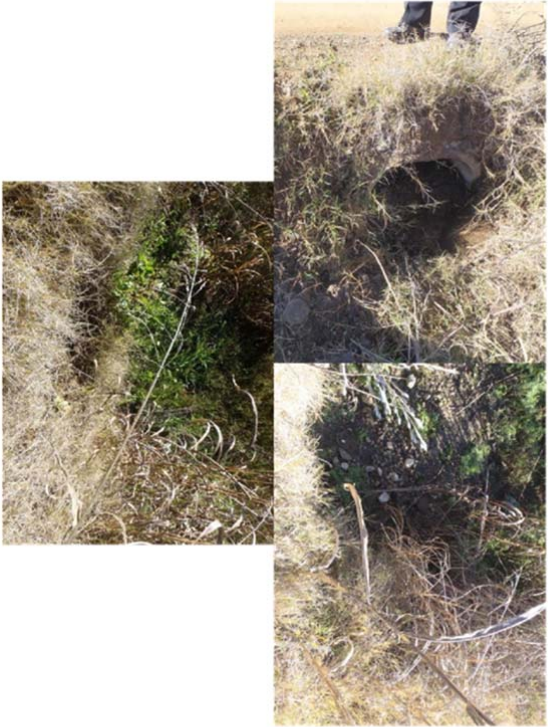
Culvert Id	Approximate Measurement Location (kilometres)	Width (metres)	Comments	Photos
CGSR41_00 4714	4.714	Unsealed: 6.2m Culvert: 7.2m	Concrete, single pipe. Unable to complete a visual inspection of the culvert due to vegetation build-up blocking the entrance to the culvert.

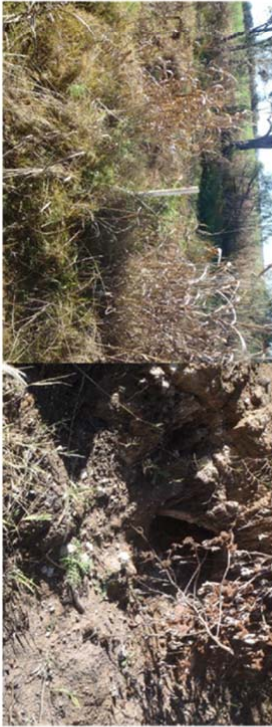
Culvert Id	Approximate Measurement Location (kilometres)	Width (metres)	Comments	Photos
CGSR41_00 5120	5.120	Unsealed: 6.0m Culvert: 7.2m	Concrete, single pipe. Unable to complete a visual inspection of the culvert due to vegetation build-up blocking the entrance to the culvert.	 
CGSR41_00 5237	5.237	Unsealed: 6m Culvert: 7.2m	Concrete, single pipe. Unable to complete a visual inspection of the culvert due to vegetation and silt build-up blocking the entrance to the culvert.

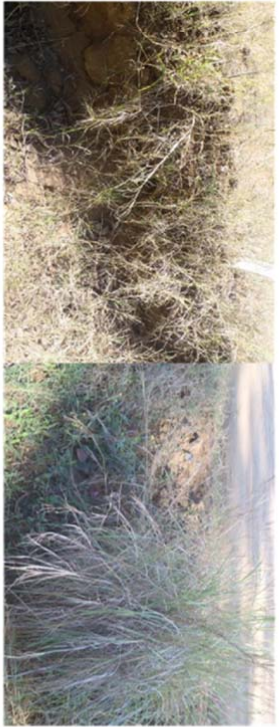
Culvert Id	Approximate Measurement Location (kilometres)	Width (metres)	Comments	Photos
CGSR41_00 5881	5.881	Unsealed: 6.0m Culvert: 7.2m	Concrete, single pipe. Unable to complete a visual inspection of the culvert due to vegetation and silt build-up blocking the entrance to the culvert.

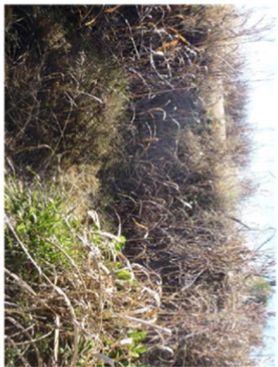
Culvert Id	Approximate Measurement Location (kilometres)	Width (metres)	Comments	Photos
CCSR41_00 8206	8.206	Unsealed: 9.5m Culvert: 10.0m	Concrete, four (4) pipes. Unable to complete a visual inspection of the culvert due to vegetation build-up blocking the entrance to the culvert.

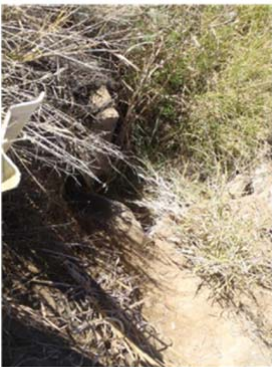
Culvert Id	Approximate Measurement Location (kilometres)	Width (metres)	Comments	Photos
CGSR41_00 9299	9.299	Unsealed: 6.2m Culvert: 7.0m	Concrete, single pipe.  Unable to complete a visual inspection of the culvert due to vegetation build-up blocking the entrance to the culvert.  Visible washout on right side.

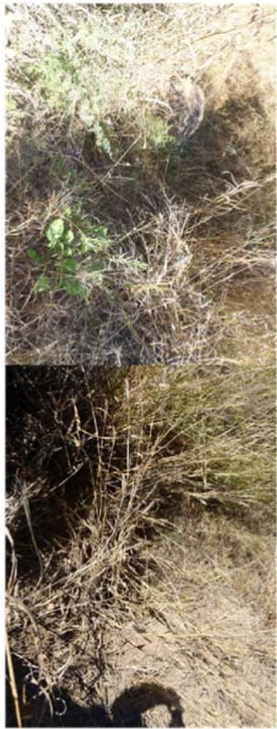
CGSR41_00 9633	9.633	Unsealed: 7.0m Culvert: 9.8m	Concrete, single pipe.  Unable to complete a visual inspection of the culvert due to vegetation build-up blocking the entrance to the culvert.

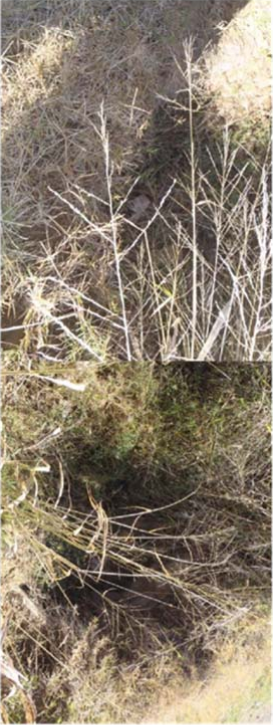
Culvert Id	Approximate Measurement Location (kilometres)	Width (metres)	Comments	Photos
CGSR41_00 9864	9.864	Unsealed: 7.2m Culvert: 10.0m	Concrete, single pipe. Unable to complete a visual inspection of the culvert due to vegetation build-up blocking the entrance to the culvert.

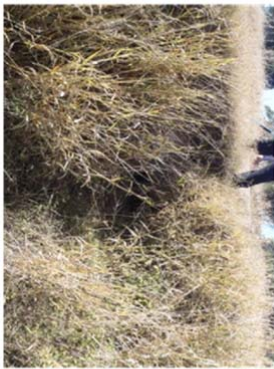
CGSR41_01 1404	11.404	Unsealed: 7.2m Culvert: 10.0m	Concrete, single pipe. Unable to complete a visual inspection of the culvert due to vegetation build-up blocking the entrance to the culvert.

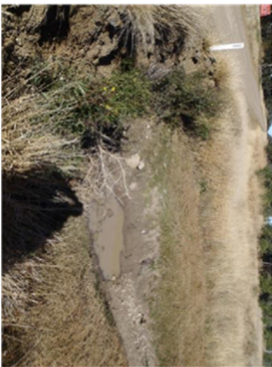
Culvert Id	Approximate Measurement Location (kilometres)	Width (metres)	Comments	Photos
CGSR41_01 2107	12.107	Unsealed: 6.6m Culvert: 10.6m	Concrete, single pipe. Unable to complete a visual inspection of the culvert due to vegetation build-up blocking the entrance to the culvert.

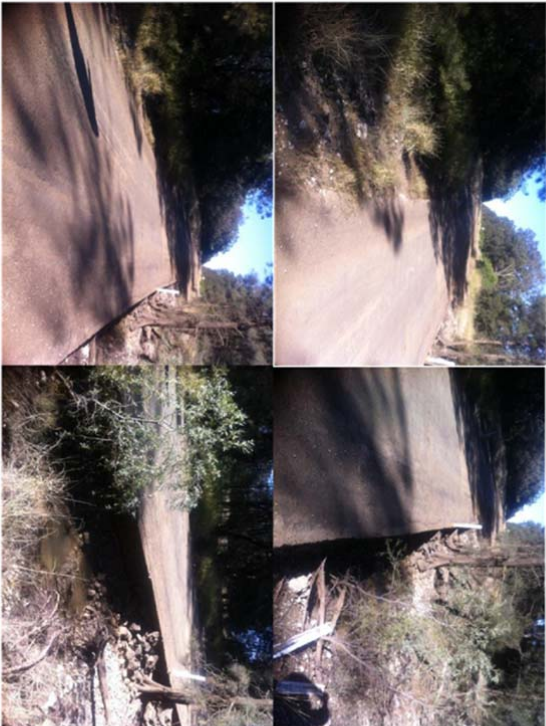
Structure Id	Approximate Measurement Location (kilometres)	Width (metres)	Comments	Photos
SGSR41_00 1128	1.128	Floodway: 6.1m Length: 31m	Floodway – concrete Flood damage visible. Repairs required.

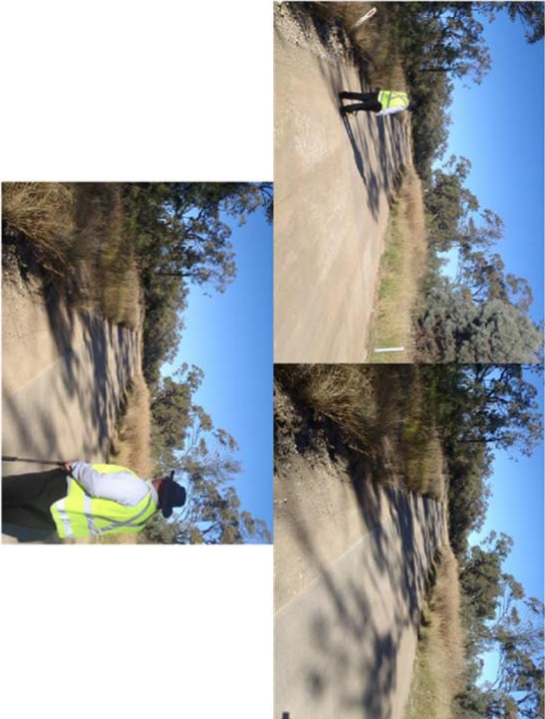
Structure Id	Approximate Measurement Location (kilometres)	Width (metres)	Comments	Photos
SGSR41_00 2887	2.887	Seal: 6.2 Edge to Edge: 7.0 Length: 54	Causeway – concrete with poor line of sight due to vegetation height. Suggest vegetation control.

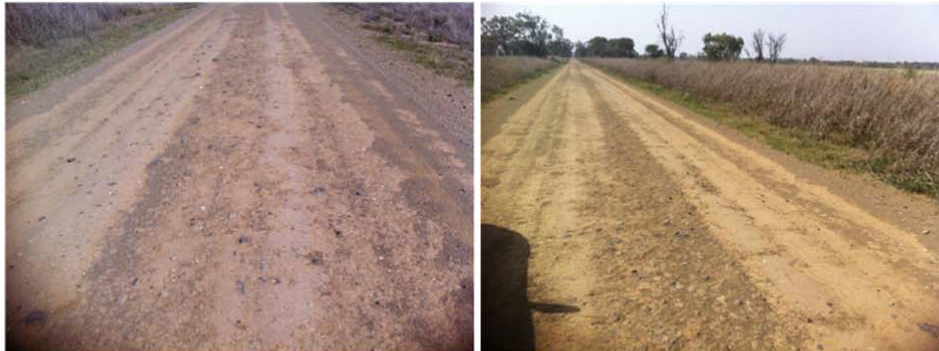
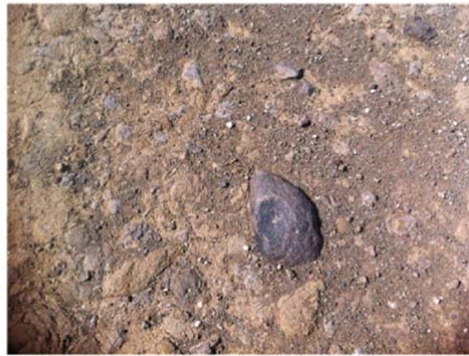
There are a significant number of large rocks visible in the road pavement right along this assessed section of road. It is suggested that as part of routine maintenance, a rock crusher be passed over the road to help reduce the number and size of the rocks.
