**Item 10 A-Double Modern Road Train Assessment**

The purpose of this report is to allow Council to make a determination for restricted vehicle access (A-double Modern Road Train access) on a 12.180km section of County Boundary Road (SR41), south from the intersection of Gil Gil Creek Road (SR63) to the Moree Plains Shire Boundary.

# Gwydir Shire Council Route Assessment Report

## *SR 41 County Boundary Road from Moree Plains and Gwydir Shire Boundary to intersection of Croppa Moree Road (Moree Plains Shire)* Wednesday, 3 July 2013

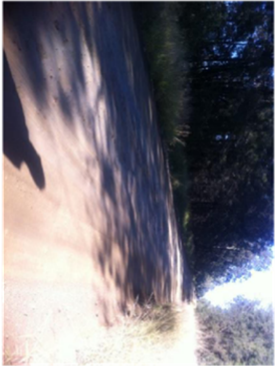
• Causeway (concrete) – 2.887km from the Moree Plains and Gwydir Shire southern boundary – No structural engineer’s report available and therefore structural capacity is unknown.			✓

2.887	Unsealed: 6.2 m Edge to edge: 6.6m Formation: 6.6m	Causeway

Structure Id	Approximate Measurement Location (kilometres)	Width (metres)	Comments	Photos
SGSR41_00 2887	2.887	Seal: 6.2 Edge to Edge: 7.0 Length: 54	Causeway – concrete with poor line of sight due to vegetation height. Suggest vegetation control.

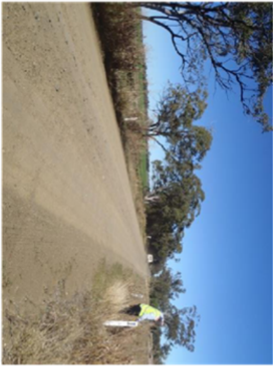
8.206	Unsealed: 9.5m Culvert: 10.0m Formation: 10.0m	Culvert

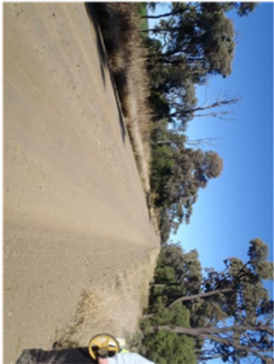
• Causeway (concrete) – 8.856km from the Moree Plains and Gwydir Shire southern boundary – No structural engineer’s report available and therefore structural capacity is unknown.			✓

8,856	Unsealed: 6.2 m Edge to edge: 7.2m Formation: >8.5m	Causeway

Structure Id	Approximate Measurement Location (kilometres)	Width (metres)	Comments	Photos
SGSR41_00 8856	8.856	Seal: 6.2 Edge to Edge: 7.2 Length: 30	Causeway – concrete Large drop off at northern end. Suggest maintenance works.

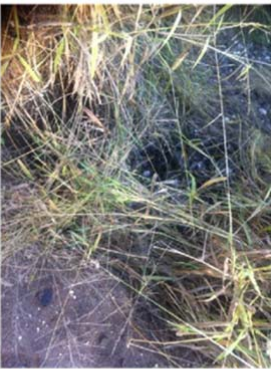
Culvert Id	Approximate Measurement Location (kilometres)	Width (metres)	Comments	Photos
CGSR41_00 1337	1.337	Unsealed: 7.2m Culvert: 7.5m	Culvert - concrete, single pipe
